Manhole Inspection Summary

Manhole # S41I2_004MH

Insp Date: **3/31/08 9:55 AM**

Location Address: **4501 Virginia Ave.**

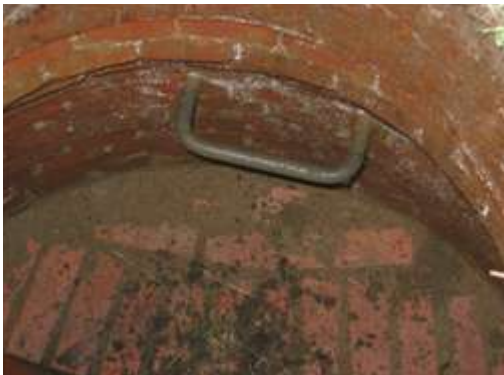
steps

Count: **1** Missing: **0** ☐ Corroded

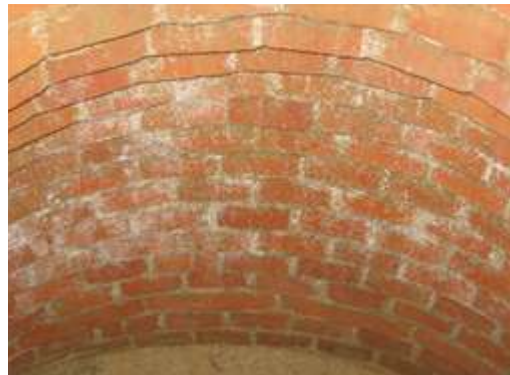
Defect 1

Fungus developed on the wall due to surface runoff

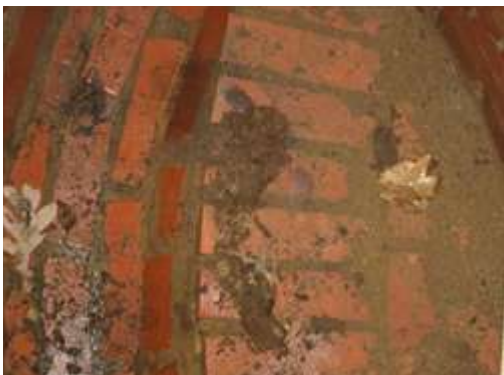
Defect 2

Little bit of debris on the bench

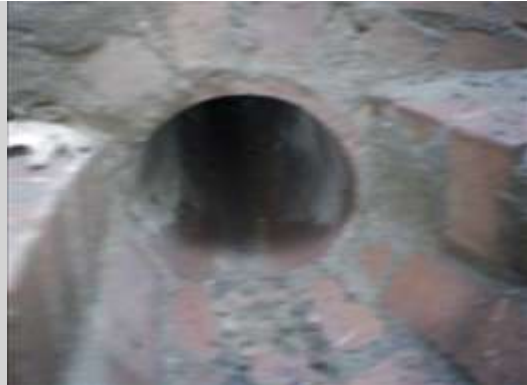
12 O'Clock Outflow

8 in. Circular Gravity Sewer
Pipe Out @ 12 O'Clock

Infiltration: **None** Pipe Seal Cond: **Sound**

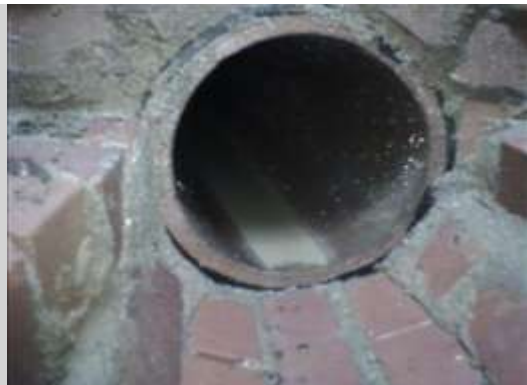
5 O'Clock Inflow

8 in. Circular Gravity Sewer
Pipe In @ 5 O'Clock

Infiltration: **None** Pipe Seal Cond: **Sound**
